**DEPARTMENT OF TRANSPORTATION**

Contract #: 04-0120F4Cty: SF/ALA Rte: 80 PM: 13.2/13.9File #: 69.28**WELDING INSPECTION REPORT****Resident Engineer:**Pursell, Gary**Address:** 333 Burma Road**City:** Oakland, CA 94607**Report No:** WIR-015502**Date Inspected:** 08-Jul-2010**Project Name:** SAS Superstructure**OSM Arrival Time:** 700**Prime Contractor:** American Bridge/Fluor Enterprises, a JV**OSM Departure Time:** 1900**Contractor:** Zhenhua Port Machinery Company, Ltd (ZPMC), Changxing Island **Location:** Shanghai, China**CWI Name:** Li Yang**CWI Present:** Yes No**Inspected CWI report:** Yes No N/A**Rod Oven in Use:** Yes No N/A**Electrode to specification:** Yes No N/A**Weld Procedures Followed:** Yes No N/A**Qualified Welders:** Yes No N/A**Verified Joint Fit-up:** Yes No N/A**Approved Drawings:** Yes No N/A**Approved WPS:** Yes No N/A**Delayed / Cancelled:** Yes No N/A**Bridge No:** 34-0006**Component:** OBG Segment**Summary of Items Observed:**

**OBG # TRIAL ASSEMBLY YARD (9AW-9BW)**

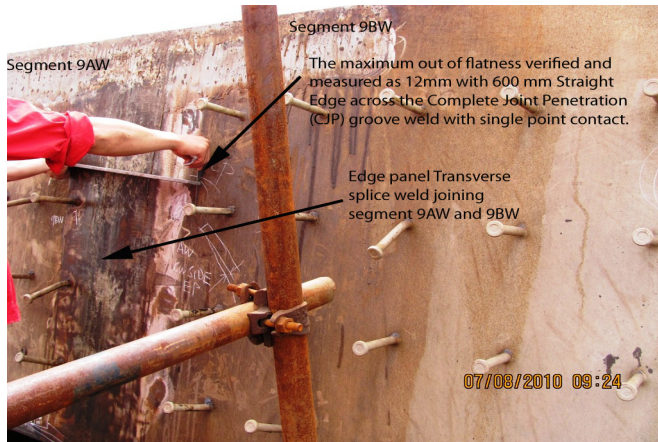
This QA inspector performed a random visual survey inspection for flatness of transverse splice segment weld at Edge Panel Counter Weight Side on Segment 9AW to Segment 9BW with the following observations. The maximum out of flatness verified and measured was 12mm using a 600 mm Straight Edge across the Complete Joint Penetration (CJP) groove weld with single point contact. The surface flatness survey data was taken on the exterior side (flat side of the weld) of the Edge panel (Counter weight side). The allowable tolerance is 10mm. The Members are identified as follows:

Transverse Splice Weld identified as OBW9-001 between Panel Point (PP) 73 and PP 74.

An incident report was generated for the out of flatness observed on the edge panel transverse splice weld of segment 9AW to segment 9BW that exceeded the allowable tolerance of 10mm. See TL-6025 generated on this date for detailed information.
